Influence of Manufacturing Processes in Deterioration of Ag-Cu Artefact Alloy

Abeer Gharib

Conservation Department, Faculty of Fine Arts, Minia University, Minia, Egypt

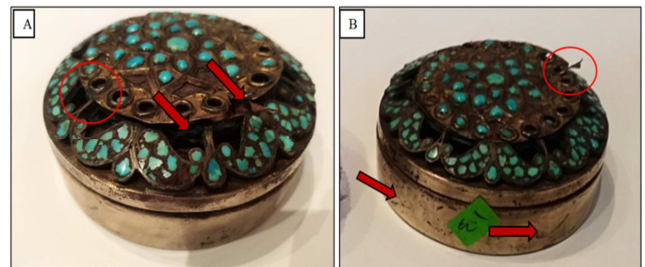
Investigation of ink box revealed that the object consists of two parts which are the ink box cover and the box body, the ink box cover appeared missing parts in inlay layers with different coloured of corrosion products, cracks, and distortion the surface or warp which built up by cold-working. The body box revealed many blowholes and shrinkage Figure 2. The body box is made by hot-working or simplest mold. This technology is like sand casting [6].

Figure 2. (2A) ink cover shows missing parts in inlay, corrosion products, cracks and distortion the surface or warps (2B) the body box shows blowholes and shrinkage.

Visual examination of silver copper ink box showed that the box made of two separate parts, the cover which made by cold-working and body box made by cast. The cover had layers of corrosion, miss in inlay layers, cracks, and distortion the surface or warp. The body box had blowholes and shrinkage in outer surface.

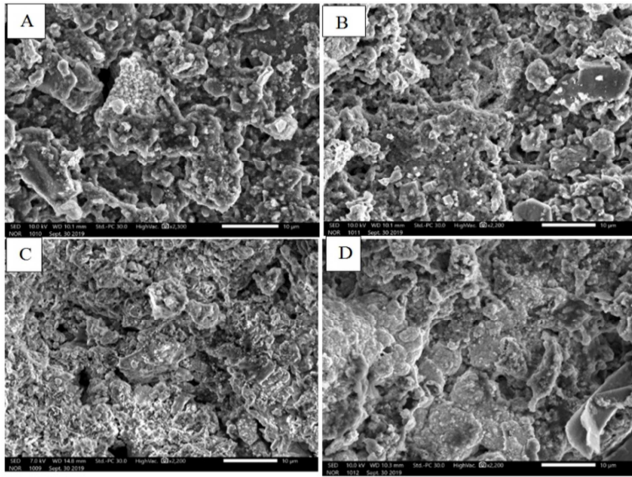
SEM micrographs of fracture surface showed the presence of corrosion layers with different grain size, Figure 3 intergranular cracking and regions of ductile fracture and brittle. EDX Figure 4 and tables 1 and 2 determined chemical composition of the ink box alloy from 15.4% silver Ag, 2.1% copper Cu, 2.5% Zn and the elemental corrosion layers from C, O, S, Cl, Si, Na, Ca, Al.

Figure 3. SEM micrograph showed fracture surface for interfacial cracking (a, b) corrosion layers with different grain size, (c) intergranular cracking and regions of ductile fracture, (d) brittle intergranular fracture.

Examination by SEM micrograph revealed embrittlement in corrosion layers. The corrosion layers showed intergranular cracking and regions of ductile fracture. SEM micrograph reveal the object has undergone extensive plastic deformation, resulting in strain-hardening. SEM micrographs for etching sample showed pores and crack propagation.

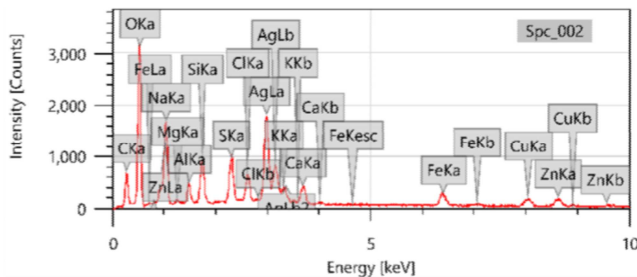
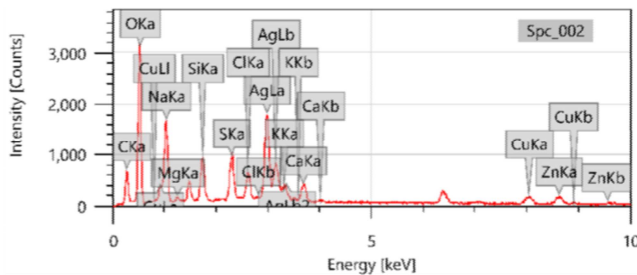
Figure 4. EDX of samples show the alloy consists of silver and copper and elemental corrosion layers from C, O, S, Cl, Si, Na, Ca, and Al.

The EDX analysis reveals that the object is made of silver Ag that contains Cu and Zn. Elements such as C, O, Cl, S, Al, Si, Na, K, Ca, Fe observed at the corrosion layer of the object.

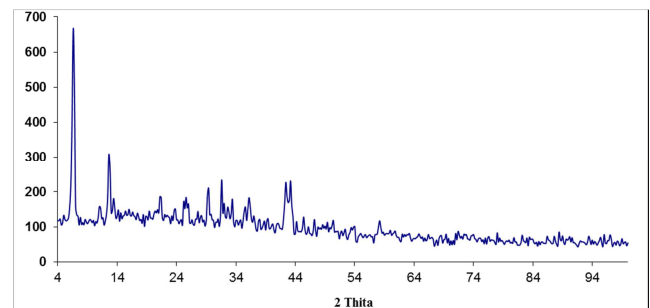
X-Ray diffraction analysis Figure 6 and table 3 revealed the corrosion layers consisted of Montmorillonite as a major mineral, Atacamite, Malachite as minor minerals; and Paratacamite, Cuprite, Acanthite, Tenorite, Calcite, Chlorargyrite, Copper as traces minerals.

Figure 6. X-Ray diffraction analysis showed corrosion layers consisted of Montmorillonite as a major mineral, Atacamite, Malachite as minor minerals; and Paratacamite, Cuprite, Acanthite, Tenorite, Calcite, Chlorargyrite, Copper as traces minerals.

The XRD analysis confirmed the EDX analysis that the corrosion compounds consist of Montmorillonite $\text{NaO}_3(\text{Al, Mg})_2\text{Si}_4\text{O}_{10}(\text{OH})_2 \cdot x\text{H}_2\text{O}$, Atacamite $\text{Cu}_2\text{Cl}(\text{OH})_3$, Malachite $\text{Cu}_2\text{CO}_3(\text{OH})_2$, Paratacamite $\text{Cu}_2\text{Cl}(\text{OH})_3$, Cuprite Cu_2O , Acanthite Ag_2S , Tenorite CuO , Calcite CaCO_3 , Chlorargyrite AgCl , Copper Cu.
