Influence of Manufacturing Processes in Deterioration of Ag-Cu Artefact Alloy

Abeer Gharib

Conservation Department, Faculty of Fine Arts, Minia University, Minia, Egypt

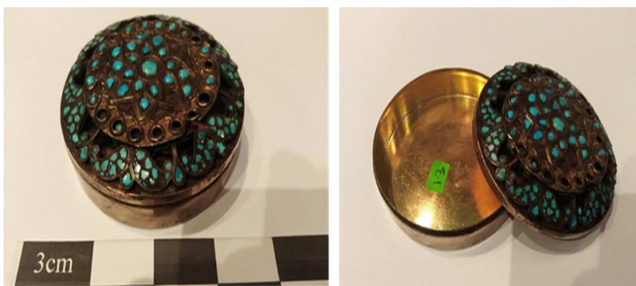
The ink box is made from two parts Figure 1, the upper part is an ink box cover and the lower part is a box body. The ink box cover has been built up from sheet components brazed together to form outer and inner jackets, the outer sheet engraved with decorative channels or chased and inlaid with enamel. The lower part (box body) is made by casting.

Figure 1. The ink box made from two parts and inlays with enamel.
